70 Orchard Way, Inchtute, Perth, PH14 9QB

Scottish Single Survey

| Date of inspection | 13th September 2017 |

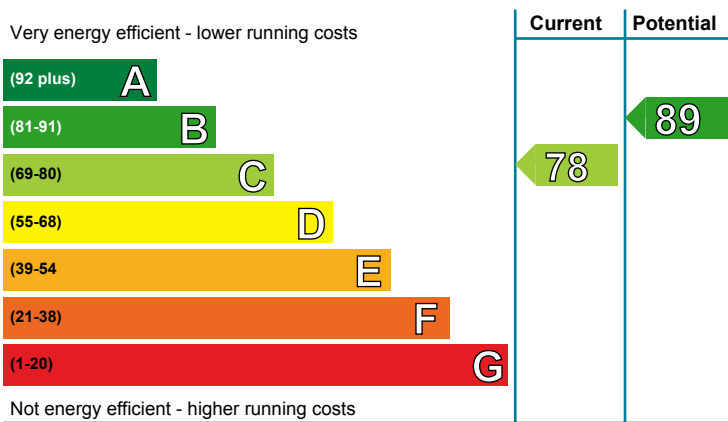
Energy Efficiency Rating

Your current rating is **band C (78)**. The average rating for EPCs in Scotland is **band D (61)**.

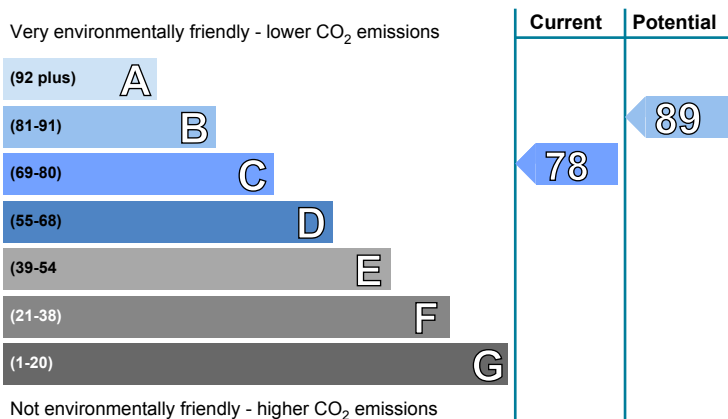
Environmental Impact (CO₂) Rating

Your current rating is **band C (78)**. The average rating for EPCs in Scotland is **band D (59)**.
