Energy Performance Certificate (EPC)

CRAIGENROAN, 15A NORTH LATCH ROAD, BRECHIN, DD9 6LF

Single Survey

Property address	'CRAIGENROAN' 15A NORTH LATCH ROAD BRECHIN ANGUS DD9 6LF
Customer	MAY
Customer address	
Prepared by	Home Report Company
Date of Inspection	4 TH JANUARY 2021

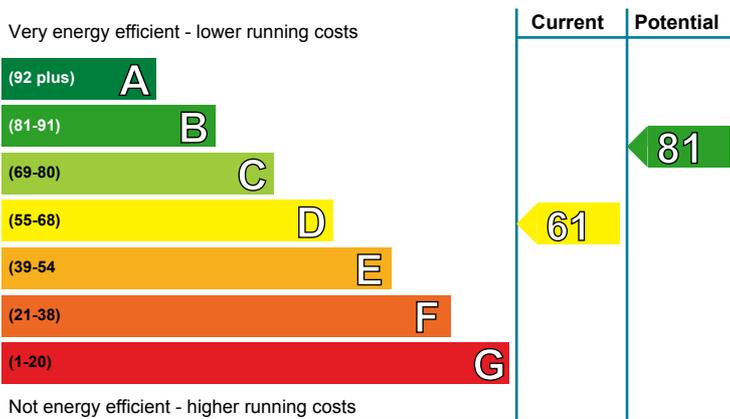
Energy Efficiency Rating

This graph shows the current efficiency of your home, taking into account both energy efficiency and fuel costs. The higher this rating, the lower your fuel bills are likely to be.

Your current rating is **band D (61)**. The average rating for EPCs in Scotland is **band D (61)**.

The potential rating shows the effect of undertaking all of the improvement measures listed within your recommendations report.

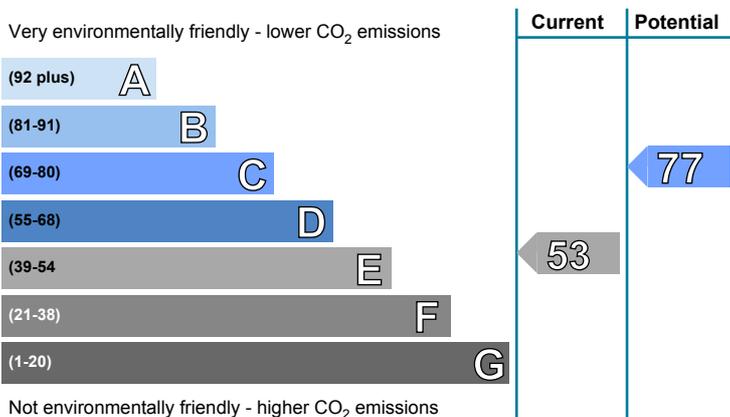
Environmental Impact (CO₂) Rating

This graph shows the effect of your home on the environment in terms of carbon dioxide (CO₂) emissions. The higher the rating, the less impact it has on the environment.

The potential rating shows the effect of undertaking all of the improvement measures listed within your recommendations report.

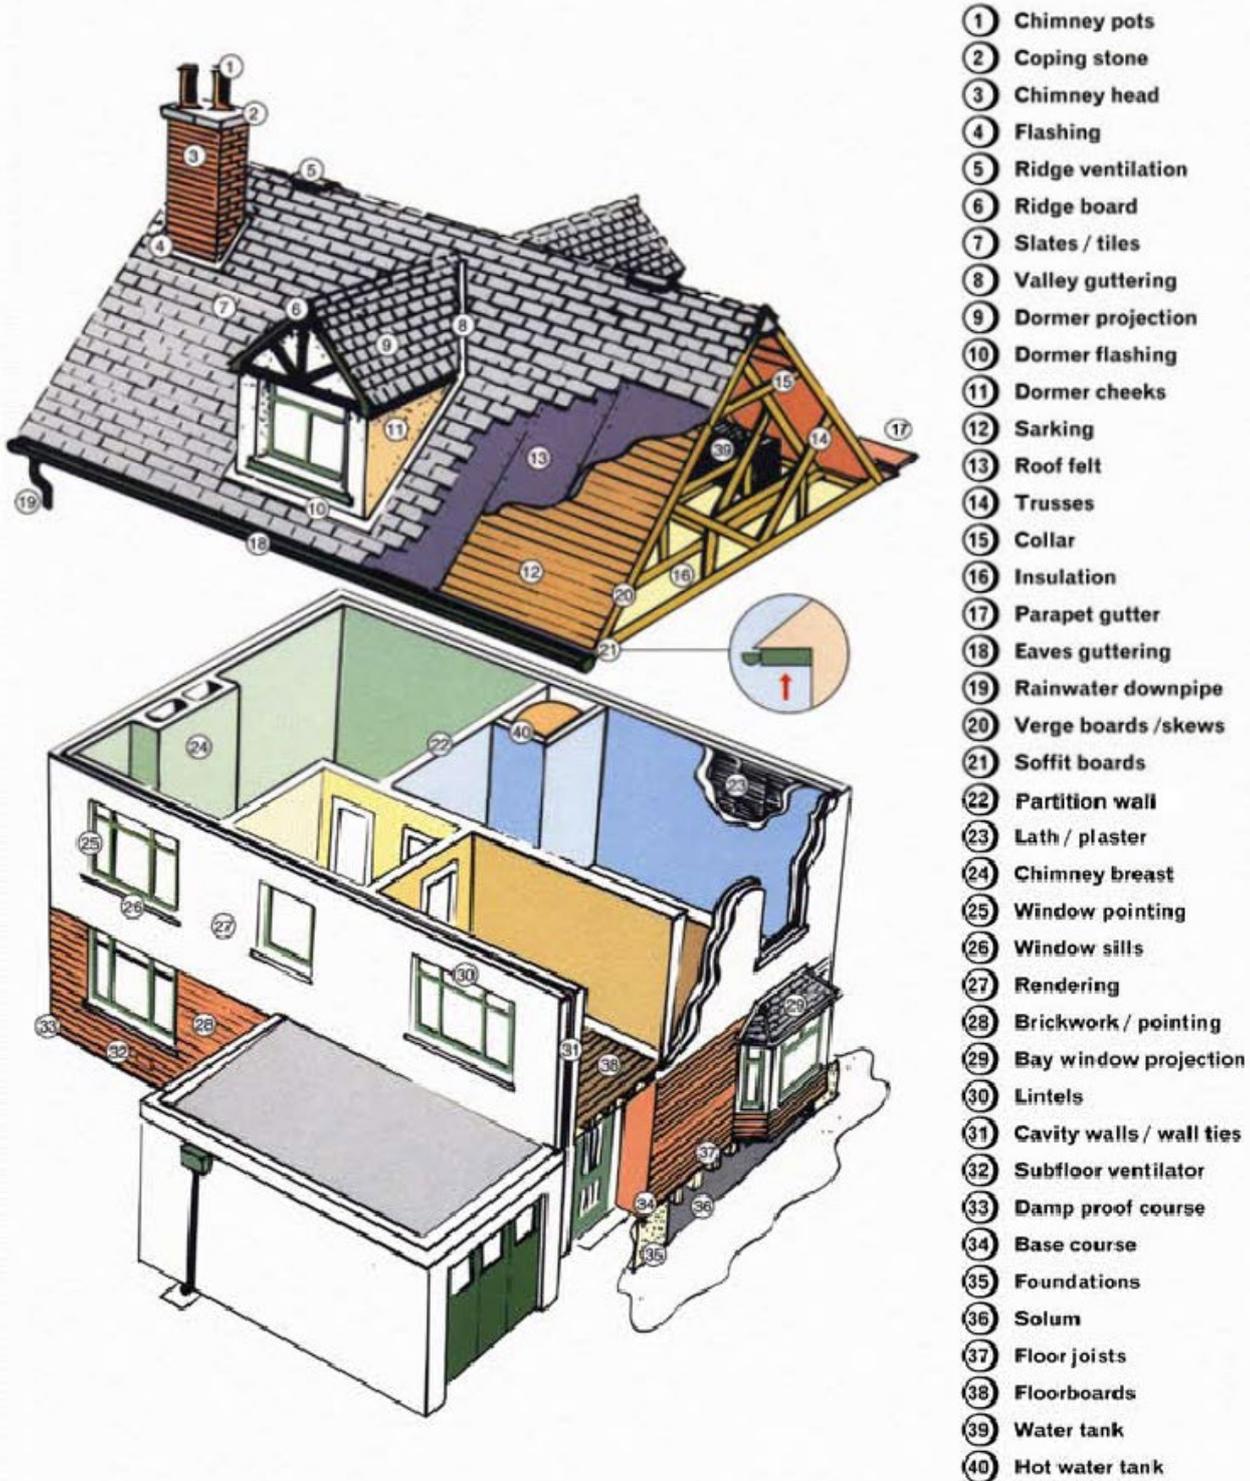
Sectional Diagram showing elements of a typical house

Reference may be made in this report to some or all of the above component parts of the property. This diagram may assist you in locating and understanding these items.
