Energy Performance Certificate (EPC)

4 CAENLOCHAN GARDENS, ARBROATH, DD11 3HN

Scottish Single Survey

Single Survey

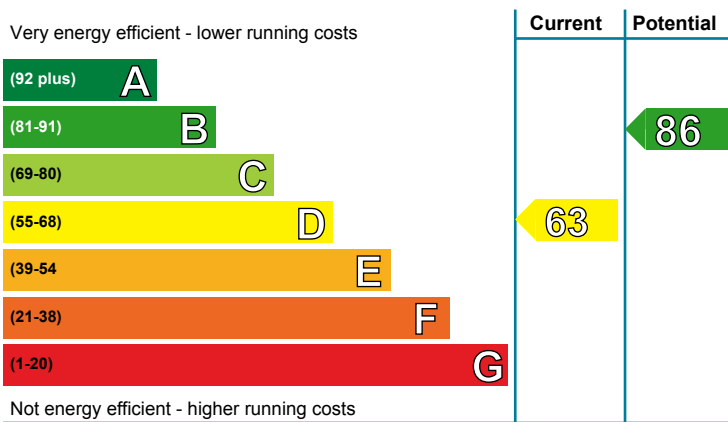
Energy Efficiency Rating

This graph shows the current efficiency of your home, taking into account both energy efficiency and fuel costs. The higher this rating, the lower your fuel bills are likely to be.

Your current rating is **band D (63)**. The average rating for EPCs in Scotland is **band D (61)**.

The potential rating shows the effect of undertaking all of the improvement measures listed within your recommendations report.

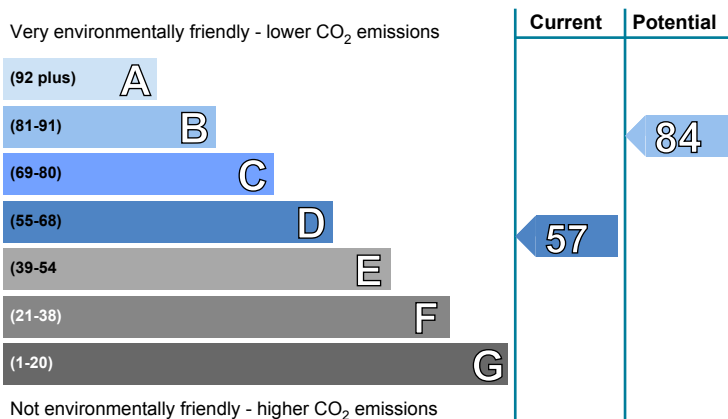
Environmental Impact (CO₂) Rating

This graph shows the effect of your home on the environment in terms of carbon dioxide (CO₂) emissions. The higher the rating, the less impact it has on the environment.

Your current rating is **band D (57)**. The average rating for EPCs in Scotland is **band D (59)**.

The potential rating shows the effect of undertaking all of the improvement measures listed within your recommendations report.
