Single Survey

survey report on:

Property address	34C Baldovan Terrace Dundee DD4 6LS
-------------------------	---

Prepared by	Graham + Sibbald
--------------------	------------------

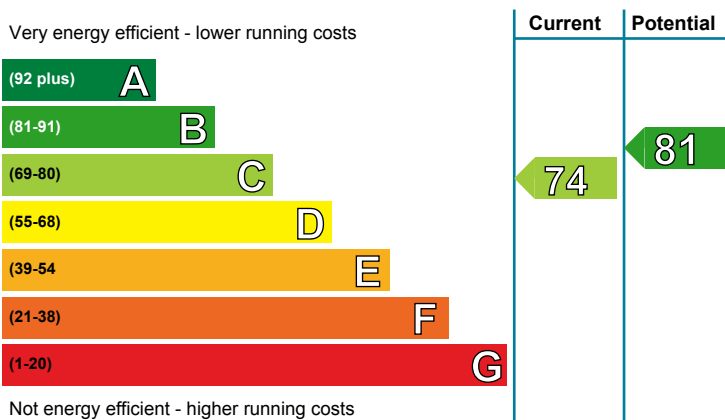
Energy Efficiency Rating

This graph shows the current efficiency of your home, taking into account both energy efficiency and fuel costs. The higher this rating, the lower your fuel bills are likely to be.

Your current rating is **band C (74)**. The average rating for EPCs in Scotland is **band D (61)**.

The potential rating shows the effect of undertaking all of the improvement measures listed within your recommendations report.

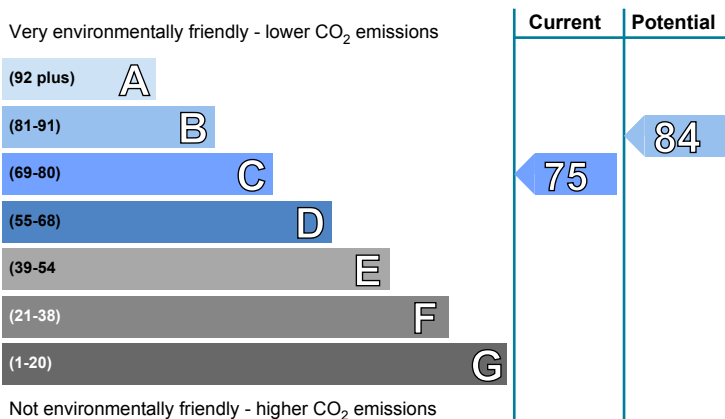
Environmental Impact (CO₂) Rating

This graph shows the effect of your home on the environment in terms of carbon dioxide (CO₂) emissions. The higher the rating, the less impact it has on the environment.
