Single Survey

survey report on:

Property address	1/1 23 Scott Street Dundee DD2 2AH
-------------------------	---------------------------------------------

Prepared by	Graham & Sibbald
--------------------	------------------

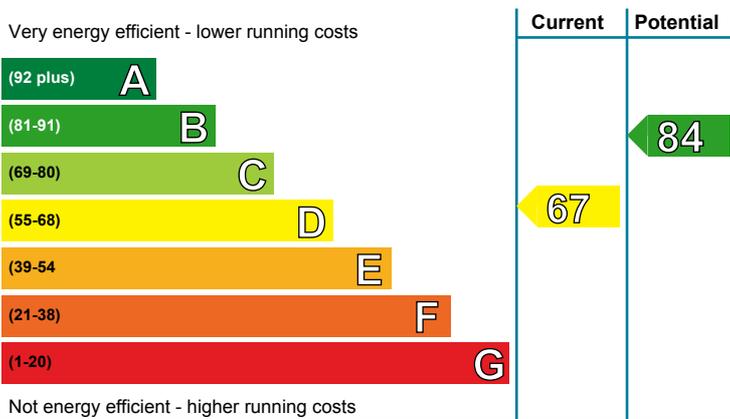
Energy Efficiency Rating

This graph shows the current efficiency of your home, taking into account both energy efficiency and fuel costs. The higher this rating, the lower your fuel bills are likely to be.

Your current rating is **band D (67)**. The average rating for EPCs in Scotland is **band D (61)**.

The potential rating shows the effect of undertaking all of the improvement measures listed within your recommendations report.

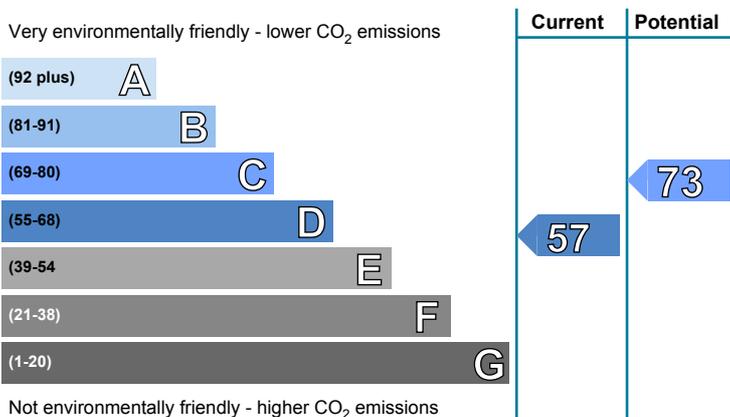
Environmental Impact (CO₂) Rating

This graph shows the effect of your home on the environment in terms of carbon dioxide (CO₂) emissions. The higher the rating, the less impact it has on the environment.
