YOUR ONESURVEY HOME REPORT

G/R
184 Lochee Road
Dundee
DD2 2NF

SINGLE SURVEY

Single Survey

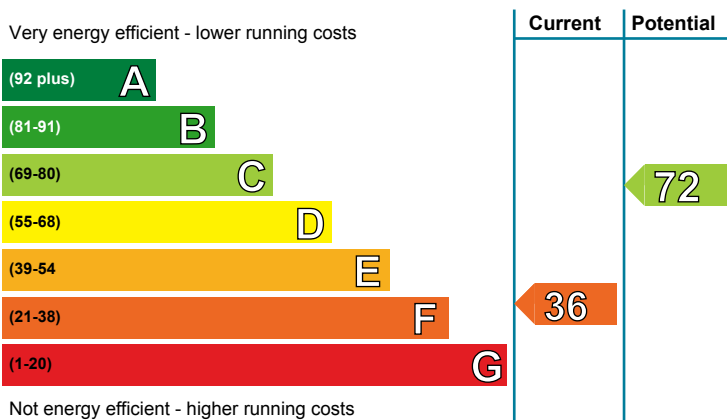
Energy Efficiency Rating

This graph shows the current efficiency of your home, taking into account both energy efficiency and fuel costs. The higher this rating, the lower your fuel bills are likely to be.

Your current rating is **band F (36)**. The average rating for EPCs in Scotland is **band D (61)**.

The potential rating shows the effect of undertaking all of the improvement measures listed within your recommendations report.

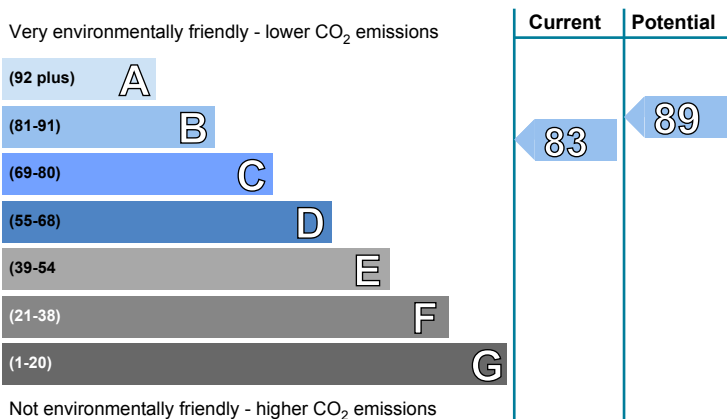
Environmental Impact (CO₂) Rating

This graph shows the effect of your home on the environment in terms of carbon dioxide (CO₂) emissions. The higher the rating, the less impact it has on the environment.
